A Flowchart for Evaluating Dairy Cow Freestalls

Ken Nordlund, DVM, Diplomate, ABVP-Dairy; Nigel B. Cook, BVSc, Cert CHP, DBR, MRCVS
Department of Medical Sciences, School of Veterinary Medicine, University of Wisconsin, Madison, Wisconsin 53706

A flowchart system has been developed to evaluate dairy freestalls. It details four critical points: adequate surface cushion; adequate body resting space; lunge room for head thrust and an unobstructed “bob-zone”; and adequate height below and behind the neck rail. Surface cushion is considered to be the most important factor in determining stall usage. If the stall allows a full forward lunge, the configuration of the stall divider has little importance. If side lunge is required, the exact height of the divider rails is critical. Several clinical problems that result from inadequate stalls are discussed.

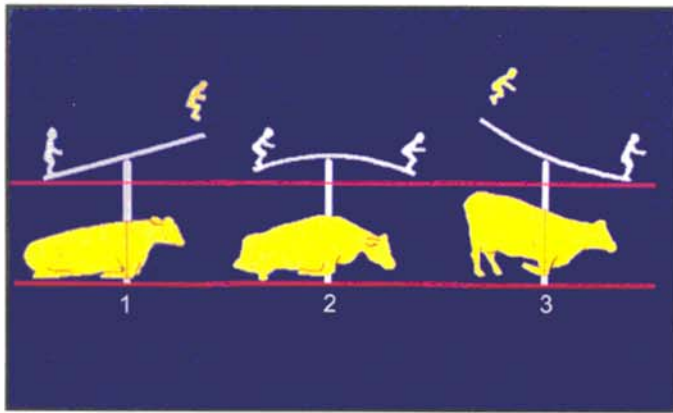
Figure 1. Schematic drawing of the cow using her carpi as a fulcrum on which to transfer weight. (Adapted from Schnitzer, 1971)¹⁸

We believe there is a need for a stall evaluation system based upon functional needs of the occupying animals for space to rest and to accommodate movements associated with rising. While some of the requirements of good stalls are related to cushion, many stall problems do not accommodate the rising motion. It is commonly said that cows rise with their rear legs first. While true, there are several critical motions that precede that step as shown in Figure 1. Cows first pull

their front legs caudally and elevate themselves upon their carpi. The carpi act as a fulcrum as the cow lunges forward and “bobs” her muzzle downward, transferring weight forward. She then rises completely on her rear legs and completes the motion by extending her front legs forward and then stepping backwards until the front legs are vertical. Failure to allow for all of these movements can result in entrapment, stall refusal, or reduced stall usage.

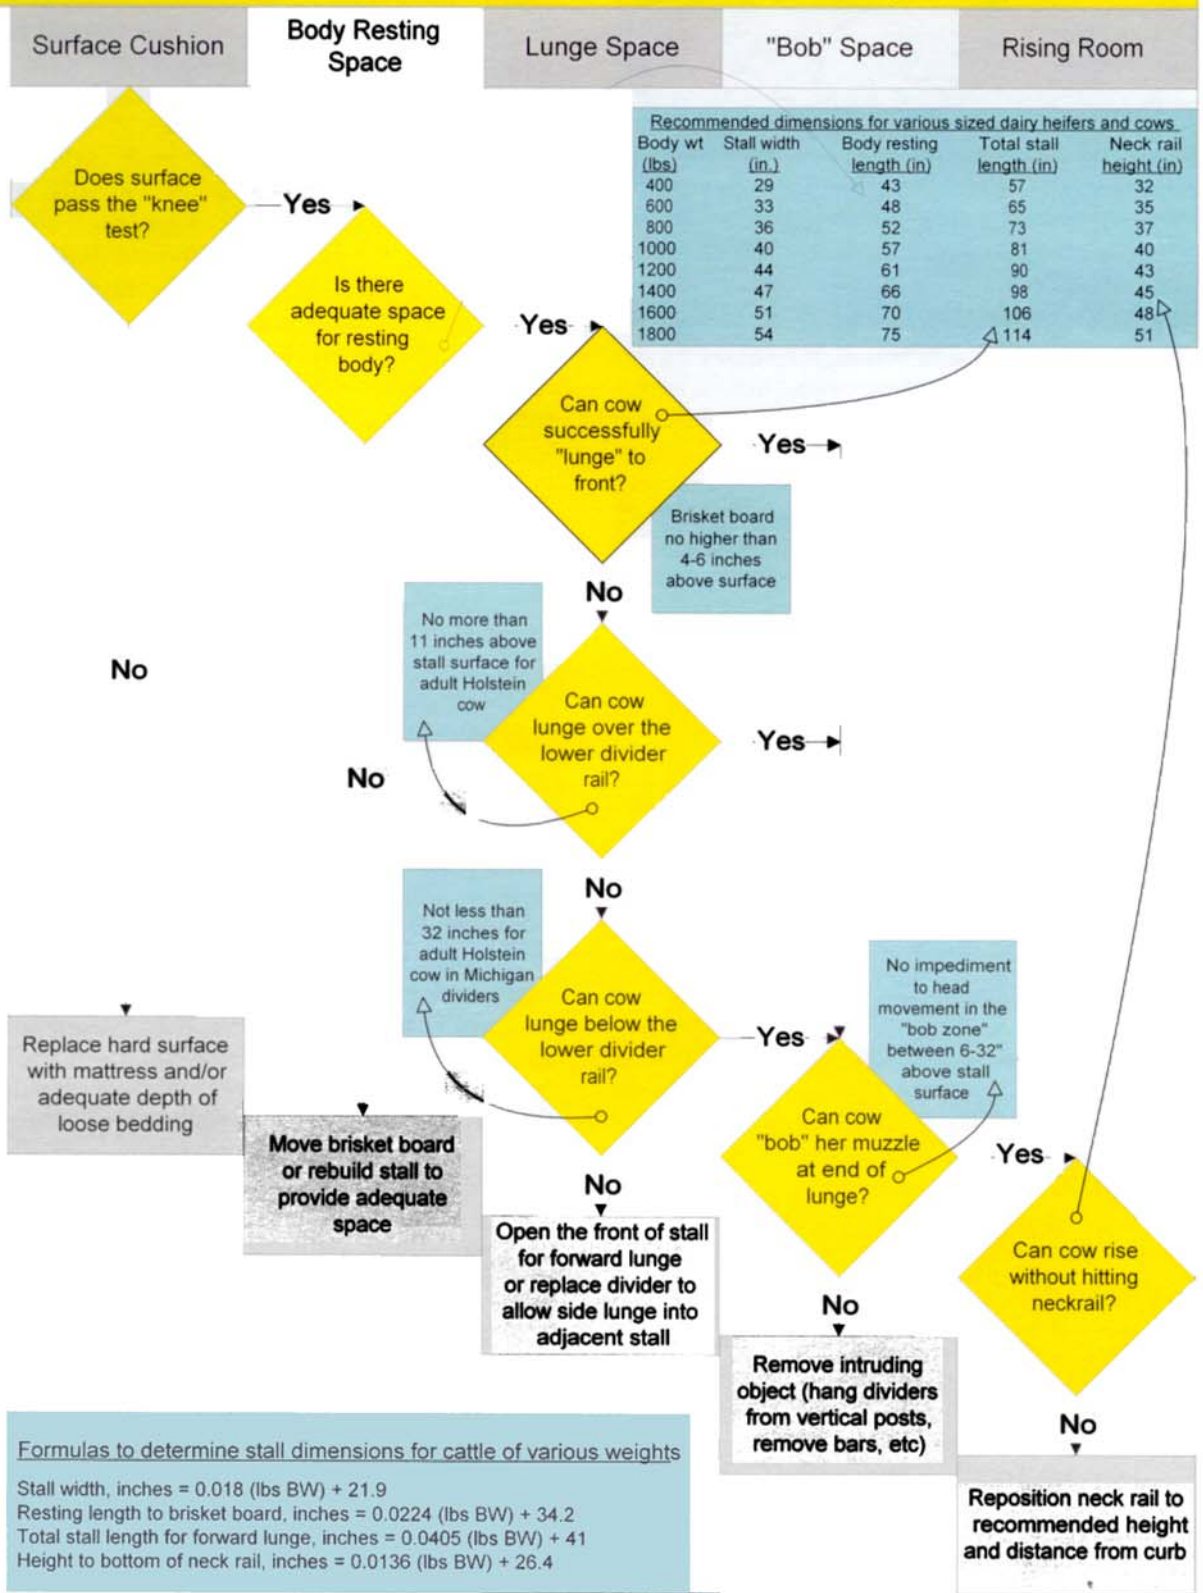
Figure 2. Flowchart for evaluating freestalls. Reprinted by permission from the May 25, 2002 issue of *Hoards Dairyman*. Copyright 2002 by W.D. Hoard & Sons Company, Ft. Atkinson, Wisconsin.

We have developed a system to evaluate four critical points: 1) adequate surface cushion, 2) adequate body resting space, 3) lunge room for head thrust and an unobstructed “bob-zone”, and 4) adequate height below and behind the neck rail. The system has been converted into a sequential flowchart shown in Figure 2. All four factors must be considered together as many stalls have multiple deficits, such as the stall in Figure 3, and correction of a single flaw will not solve a usage problem.

Stall dimensions should be based upon the largest 25% of the animals in the pen. First-lactation cows should be separated into pens with stalls sized appropriately for them. Likewise, it would be desirable to adjust stalls to accommodate very large, older cows. In the US today, it is common to find stalls constructed with 46 inches (117 cm) of width and 66 inches (168 cm) in body resting length in stalls with a total length of 7.5 feet (2.3 m). These dimensions accommodate cows to approximately 1400 lb (636 kg) and require that most cows lunge into the adjacent stall when rising. To provide comfort for 1,700 lb (773 kg) cows, stall sizes need to be substantially larger than the standard installations of today. These guidelines are compatible with recent recommendations for large Canadian cows.¹ A table of recommended stall dimensions for commonly sized animals is presented in Figure 2.

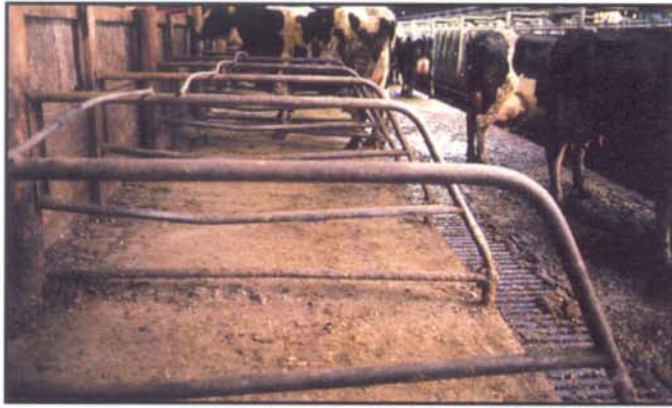
Figure 3. This freestall was common in dairy barns constructed in the 1970s and 80s. The bare concrete surface is unacceptable, the 7-foot (2-meter) platform does not allow forward lunge, the middle rail at 20 inches (51 cm) above the stall surface prevents side lunge, and the neck rail at 36 inches (91 cm) is too low. Notice that the cows have bent both the middle divider and neck rails.

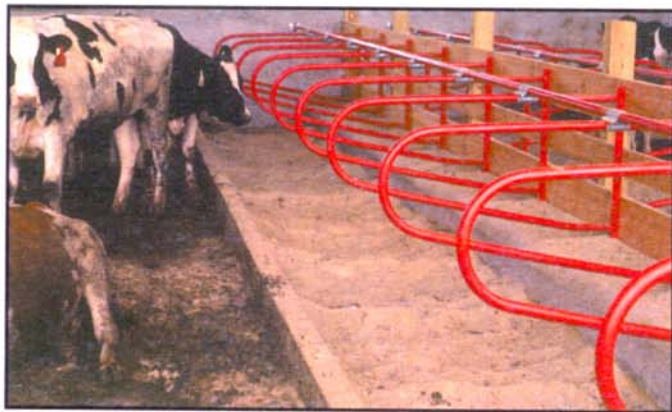
Figure 4. Failure to replace sand has caused the rear curb to protrude and shorten the effective resting body space, resulting in the heifers refusing to use the stalls.

Stalls with adequate body resting space can become inadequate because of failure to maintain bedding. As loose bedding is removed from the stall during normal usage, the rear curb gradually protrudes into the "resting surface" as shown in Figure 4. If the level of the bedding recedes more than a few inches below the curb, the net resting area is reduced by the width of the curb, making the stall unusable for some animals. In addition, the "dug out" resting surface increases the height of the brisket boards and the stall divider rails above the bed as shown in Figure 5, potentially creat-

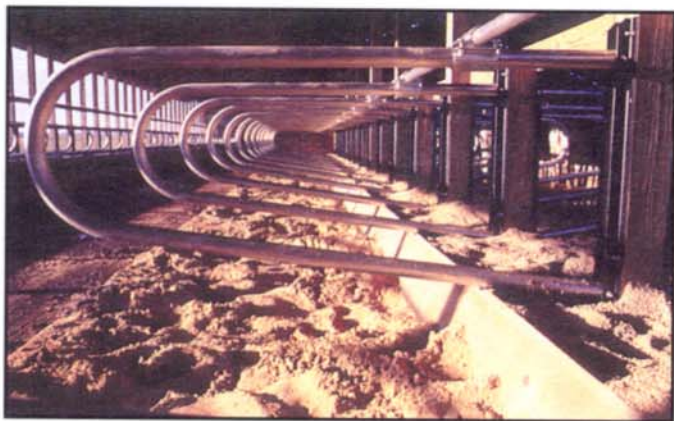
Figure 5. Failure to maintain sand has resulted in a fully exposed 2" x 12" (5 x 30 cm) brisket board, resulting in impediments to the "lunge and bob motion" and to the forward extension of the front legs.

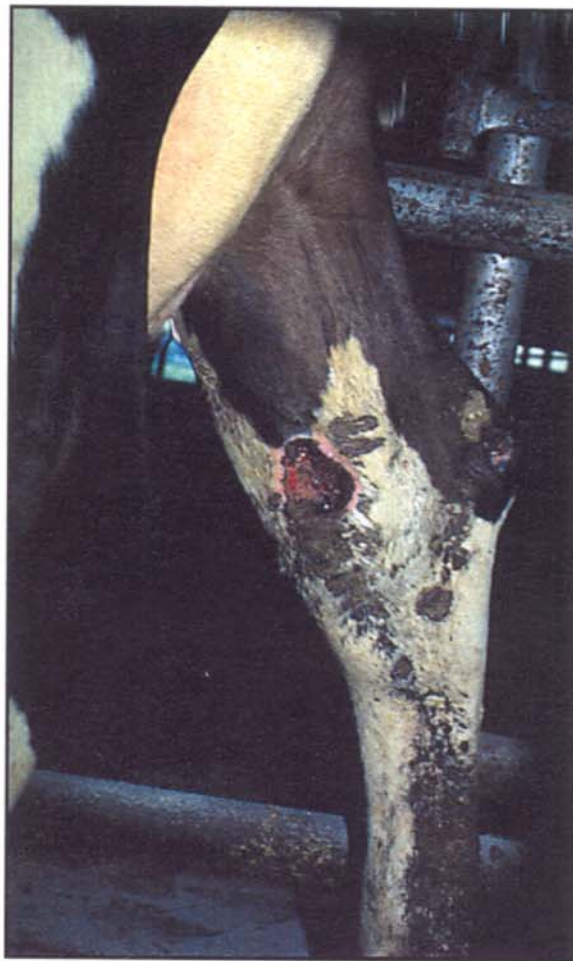
Figure 6. Medial hock ulceration related to pressure sores from leg lying across the rear curb in dug-out stalls.

Protruding rear curbs are a risk factor for medial hock ulcers of cattle. While the length of the bed may not be adequate for the cow to lie parallel to the divider, there may be adequate length on a diagonal between the brisket board and protruding curb. From the diagonal position, the upper rear leg will extend across the protruding curb out into the alley, and the full weight of the leg will rest on the bony prominence of the medial hock on the concrete curb. In a dramatic case in a herd of 900 milking cows, approximately 150 cows had developed medial hock ulcerations, as shown in Figure 6, and three cows had died of resulting infections. The sand-stall bedding crew had neglected the stalls during spring cropping activities and the problem developed during late spring. Upon diagnosis, the stalls were filled,

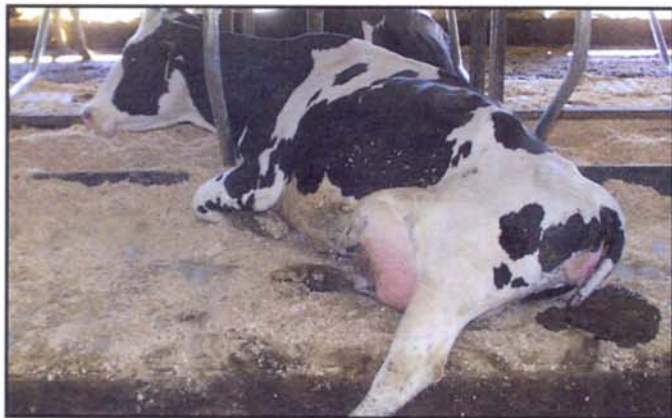
Figure 7. Cows that use side-lunge stalls tend to lie on a diagonal and defecate on the outer corners of the stalls.

The more common modification of short stalls is to provide a stall divider that allows the cow to lunge to the side into the adjacent stall. The most common design requires that the cow lunge between two rails and is called a “wide-span” divider, shown in Figure 7. It is recommended that the lower rail be no higher than 11 inches (28 cm) above the stall surface and the upper rail should not be lower than 40 inches (102 cm).² We have published a clinical report where a lower divider rail was raised to approximately 18 inches (46 cm) and resulted in significant increases in rates of mastitis and culling or deaths due to injuries and entrapment.¹⁵ Cows became entrapped because they could not successfully lunge either over, as in Figure 8, or below the divider, as in Figure 9.

Stall designs that require side lunging should be viewed as a compromised situation at best. Cows that must side lunge in stalls tend to position themselves along a diagonal across the stall bed, as in Figure 7, and tend to defecate on the outer corners of the stall platform, resulting in poor udder hygiene.

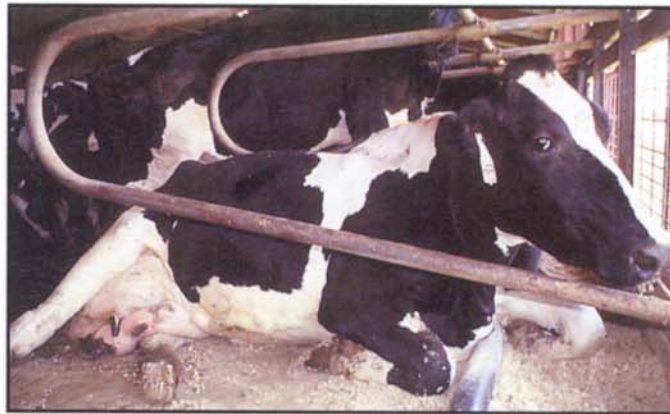
Figure 8. This cow is becoming entrapped in a 7.5 foot (2.3 m) stall after unsuccessfully trying to lunge over a rail that measured 18 inches (46 cm) above the bed near the brisket board.

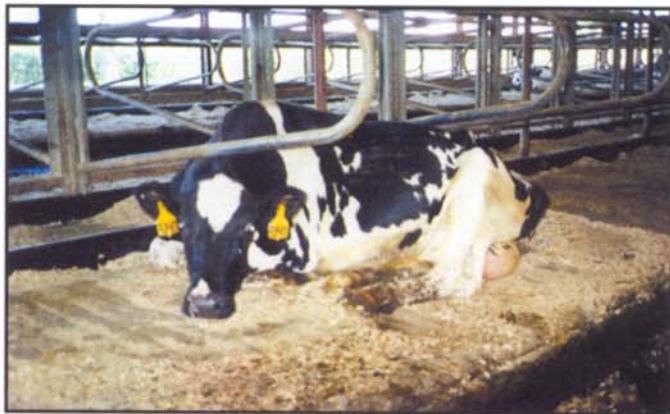
Figure 9. This cow is entrapped after trying to lunge below a lower divider rail that measures 18-20 inches (46-51 cm) above the mattress. The head-to-head stall dividers are mounted on a horizontal rail that intrudes into the bob-zone at 11 inches (28 cm) above the stall bed.

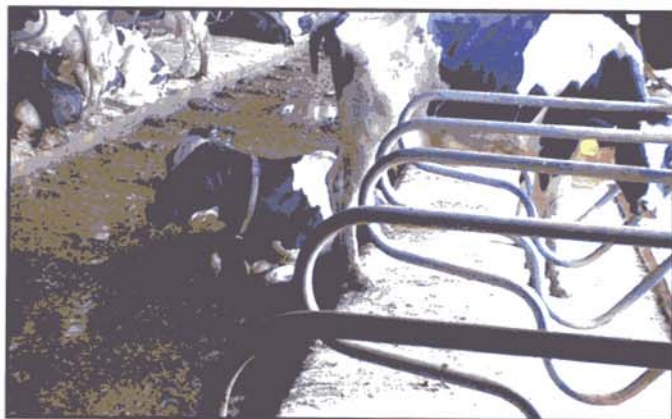
Figure 10. Poor stall usage where Michigan dividers allow only 24 inches (61 cm) of height in the lunge space below the lower rail. The neck rails are also low at 38 inches (97 cm) above the platform.

Another variation of a side-lunge divider is the “Michigan” divider, designed to allow a cow to lunge below the lower rail. For adult Holstein cows, there should be 32 inches (81 cm) of clearance below the lower bar where the lunge occurs.² Brisket boards are not usually recommended with this particular divider as they may intrude into the lunge space. In our experience, it is common to find these dividers hung too low, as in Fig-

ure 10, making it difficult for cows to rise and resulting in poor stall usage.

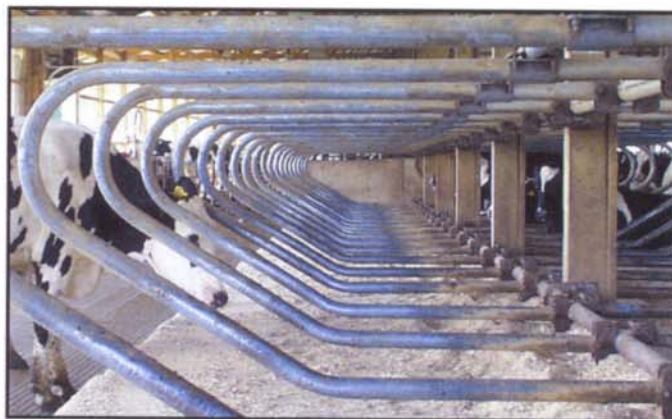
Figure 11. These dividers are mounted on a horizontal rail that intrudes into the bob-zone in these 7.5 ft (2.3 m) stalls. The lower rail of the divider reaches 10 inches (25 cm) above the mattress, which allows side lunging.

While there is a general awareness of the need for lunge room, we frequently find that the “bob-zone” is compromised. The bob-zone is the portion of the lunge space from a few inches above the stall bed to about 30 inches (76 cm) high. Sometimes this space is filled with reserves of bedding. Another infringement of the bob-zone sometimes occurs with a construction technique of mounting the stall dividers on transverse horizontal pipes, as shown

in Figure 11. If the total stall length does not allow for a full forward lunge behind the pipe, the bob-zone will be compromised and result in reduced stall usage. The dividers should be mounted on vertical posts to avoid forward obstructions in this zone.
